DEPARTMENT OF TRANSPORTATION**DIVISION OF ENGINEERING SERVICES**

Contract #: 04-0120F4Cty: SF/Ala Rte: 80 PM: 13.2/13.9File #: 69.28**WELDING INSPECTION REPORT****Resident Engineer:** Pursell, Gary**Address:** 333 Burma Road**City:** Oakland, CA 94607**Report No:** WIR-009825**Date Inspected:** 14-Oct-2009**Project Name:** SAS Superstructure**OSM Arrival Time:** 1900**Prime Contractor:** American Bridge/Fluor Enterprises, a JV**OSM Departure Time:** 700**Contractor:** Zhenhua Port Machinery Company, Ltd (ZPMC), Changxing Island **Location:** Shanghai, China**CWI Name:** See below**CWI Present:** Yes No**Inspected CWI report:** Yes No N/A**Rod Oven in Use:** Yes No N/A**Electrode to specification:** Yes No N/A**Weld Procedures Followed:** Yes No N/A**Qualified Welders:** Yes No N/A**Verified Joint Fit-up:** Yes No N/A**Approved Drawings:** Yes No N/A**Approved WPS:** Yes No N/A**Delayed / Cancelled:** Yes No N/A**Bridge No:** 34-0006**Component:** Tower and OBG Components**Summary of Items Observed:**

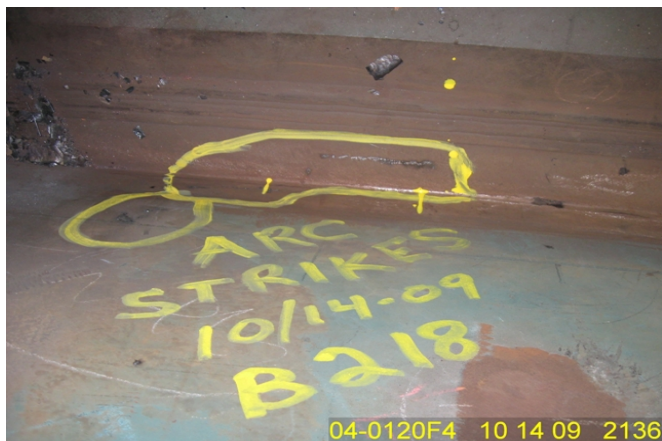
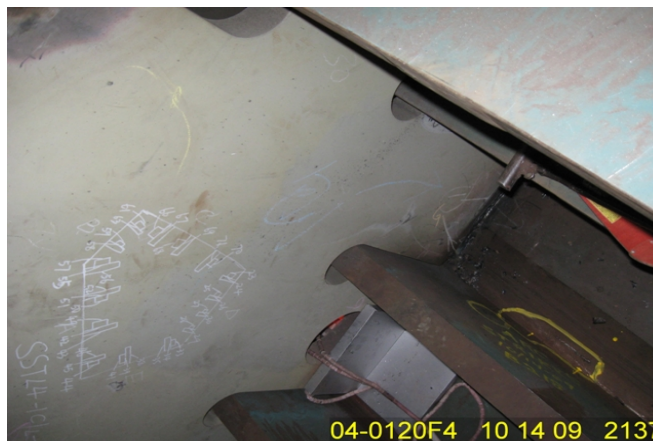
This QA Inspector observed arc strikes on skin D near skin stiffener D1 and within one meter below double diaphragm 119M of south tower, lift 4. The area was marked and reported to QC1. See photos below.
